PRODUCT SERVICE BULLETIN

Bulletin Number: FB 2021-01

SUBJECT: Firebird V1R1 EVO Harness container systems with adjustable Main Lift Web

STATUS: MANDATORY INSPECTION BEFORE NEXT JUMP

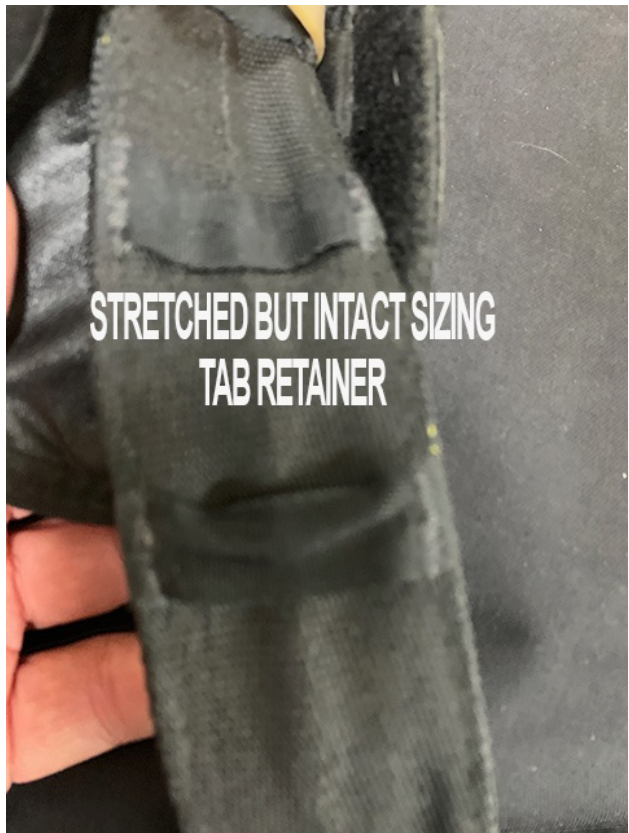
Right Main lift web undone, sizing safety tab ripped off and stuck under a stretched but intact sizing tab retainer (1/2" type 1), 555-2 ring installed **correctly**, **missing** spring, **NO** damage to type 4 stopper.

Stretched tab retainer

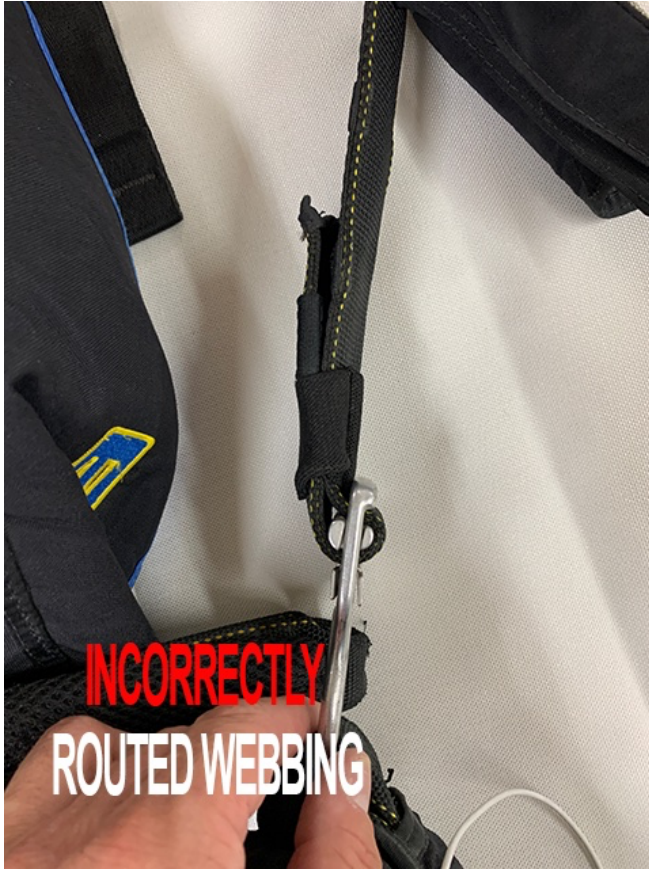
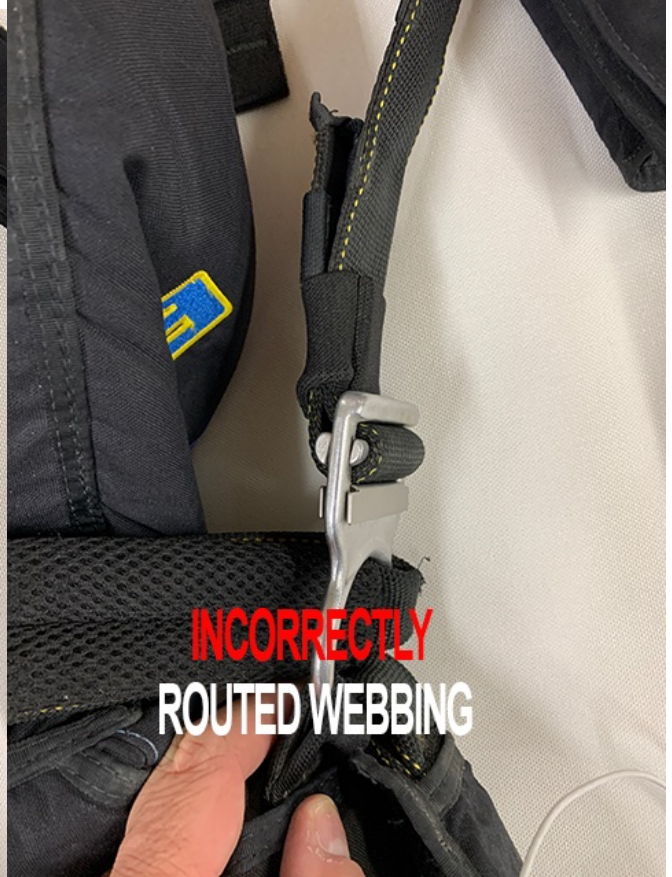
INCORRECT ROUTING PRESENT ON EVO 8611-172

Left Main lift web threaded **incorrectly** (double routing, wrong direction, see pics), sizing safety tab attached with only a few stitches (69tex/E thread) ripped, sizing tab retainer stretched but intact, 552-2 ring installed **correctly**, spring present, **NO** damage to type 4 stopper.

The incorrectly routed webbing on the **left** side strongly indicates that, the **right** side that came undone, most likely also had been routed incorrectly.

Incorrectly routed webbing will result in a slippage towards the open end and in opposite direction of the engineered purpose as the friction lock will not properly engage and not properly block the webbing from slipping.

The configuration of the incorrectly **double** routed configuration as present on the left side of the container, showed a torn off sizing safety tab **and** ripped type 4 stopper in **all** simulations at around 2000 lbs.

Therefore, we mandate a visually inspection before the next jump, to confirm the correct routing of the adjustable main lift web through a type 555-2 ring (DJA/CWH) especially if the container has been disassembled for repairs, maintenance, cleaning, or any other reason. All direct customers have been contacted by Firebird USA LLC.
